THE EFFECT OF HYDROGEN ON THE FRACTURE AND SLIP BEHAVIOR OF NICKEL

FRANK HEUBAUM AND H. K. BIRNBAUM

University of Illinois at Urbana Champaign  
Department of Metallurgy and Mining Engineering  
Urbana, IL 61801

Technical Report Office of Naval Research

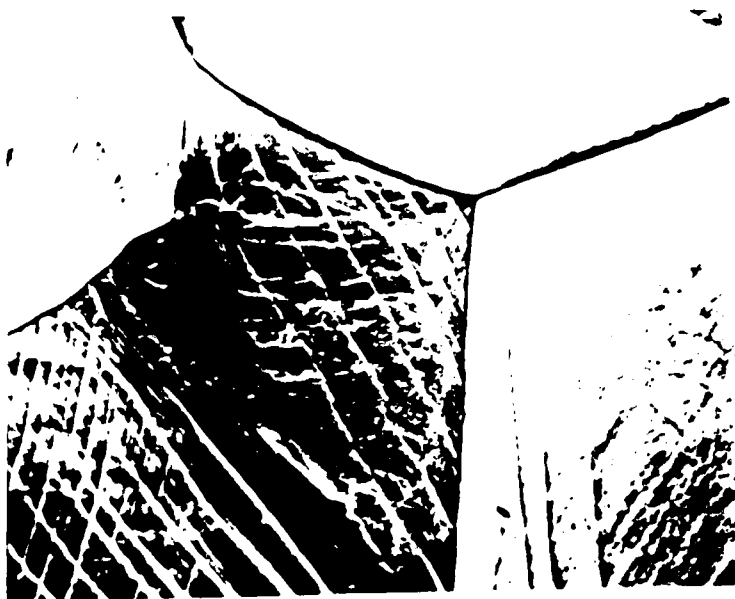
Specimen #15

Figure 12. Cracking along slip lines on an intergranular fracture surface.

A crack, once nucleated, will continue to propagate rapidly along the grain boundary until it encounters an unfavorably oriented grain at the next triple point. A large amount of localized shear would then occur along the grain boundary of the opposing grain thereby enlarging the COD as shown in Figure 8. During this process other secondary cracks may nucleate ahead of the main crack at grain boundaries and especially at triple points as illustrated in Figures 9 and 10. These secondary cracks may later link together as straining continues. This type of fracture occurs even at 113 K where the hydrogen diffusion rate is too slow to allow hydrogen to diffuse to the rapidly advancing crack tip. The relatively large COD and macroscopic ductility (25% R.A.) indicate that the fracture of hydrogenated nickel is not truly a brittle process but involves significant plasticity. Examination of the fracture surface further supports this fact in that although the fracture may approach 100% intergranular, the grain boundary fracture facets are rarely completely featureless as would be expected if fracture were due to a true decohesion process. Figure 11 shows an intergranular fracture surface which clearly reveals the deformation accompanying failure in the form of well defined intersecting slip lines. A few specimens also showed distinct cracking along slip lines on intergranular fracture facets (Fig. 12).
